NIST NCSTAR 1-5D

**Federal Building and Fire Safety Investigation of the
World Trade Center Disaster**

Reaction of Ceiling Tile Systems to Shocks

September 2005

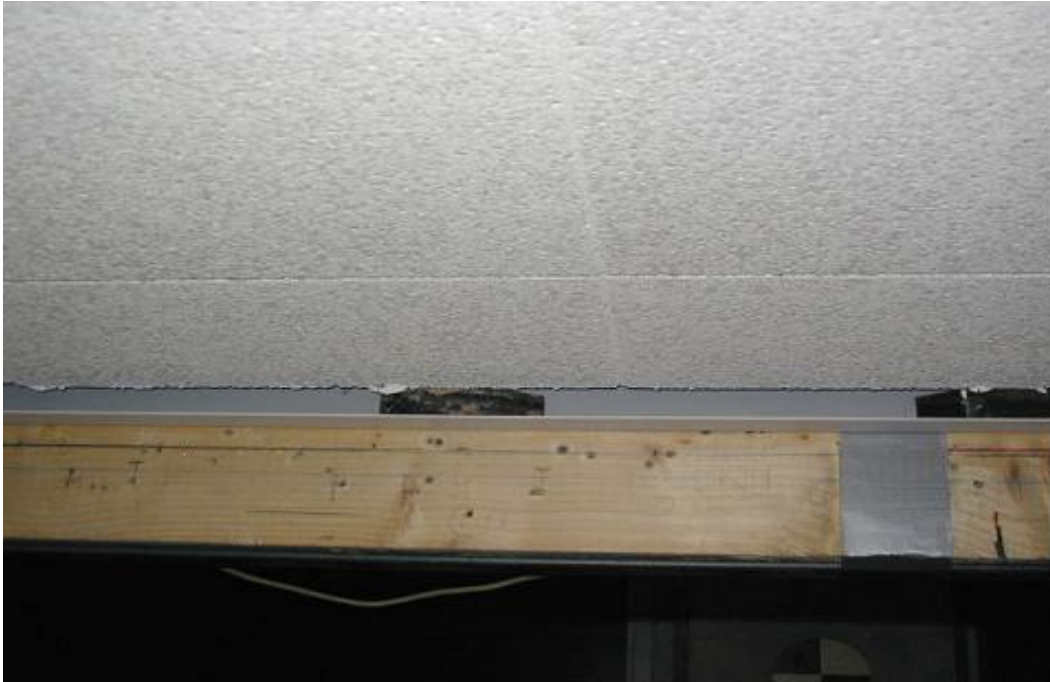
Figure 3-1. Displacement of perimeter tiles over perimeter spring clips following Test 20 for ceiling system CS1.

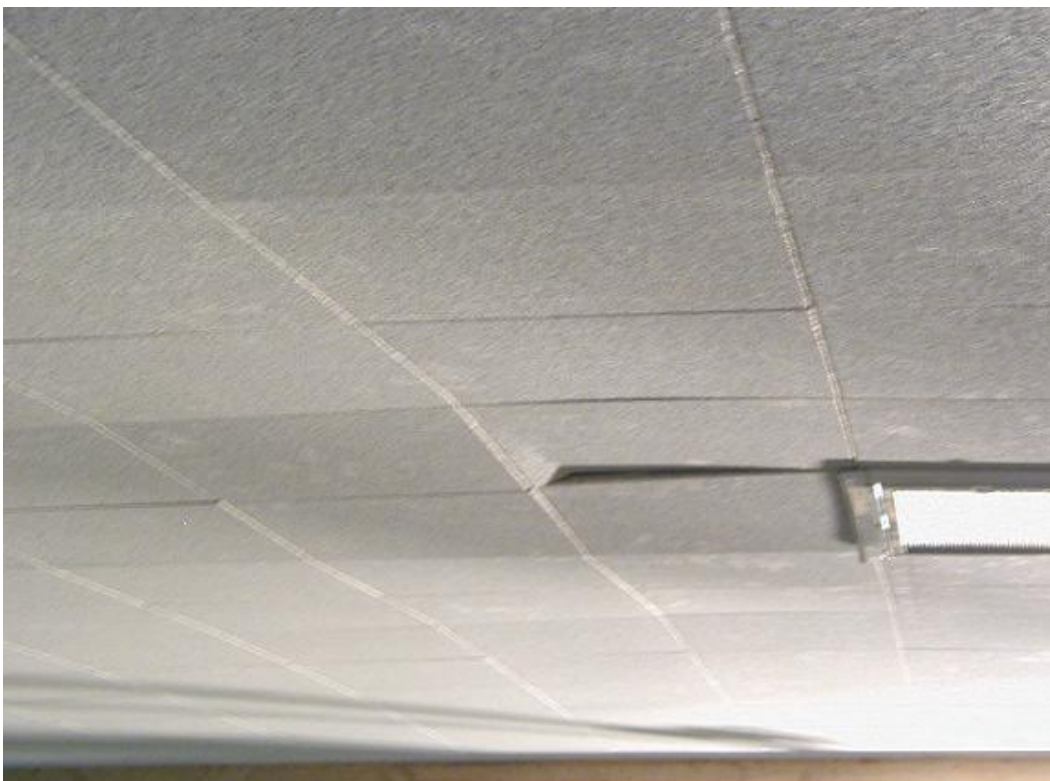
Figure 3-2. Bottom view of damage to ceiling system CS1 following Test 20.

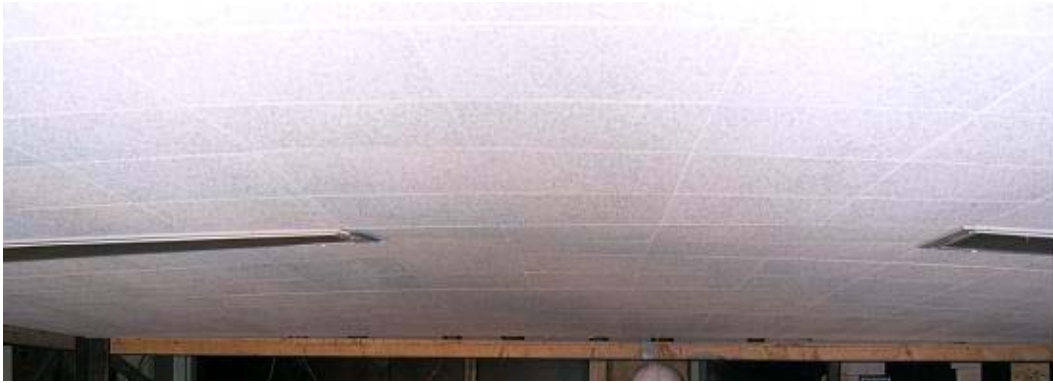
Figure 3–3. Bottom view of damage to ceiling system CS1 following Test 20.

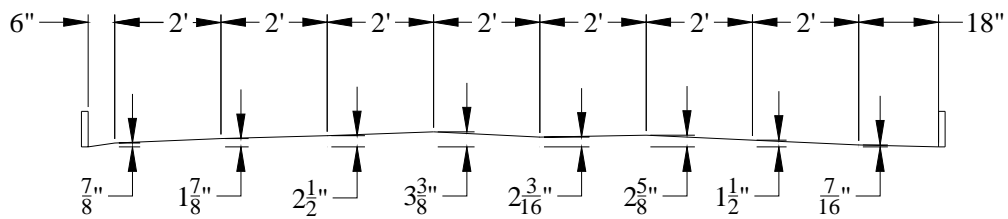
Figure 3–4. Permanent vertical displacements of Z-bars in the east-west direction following Test 20 for ceiling system CS1.

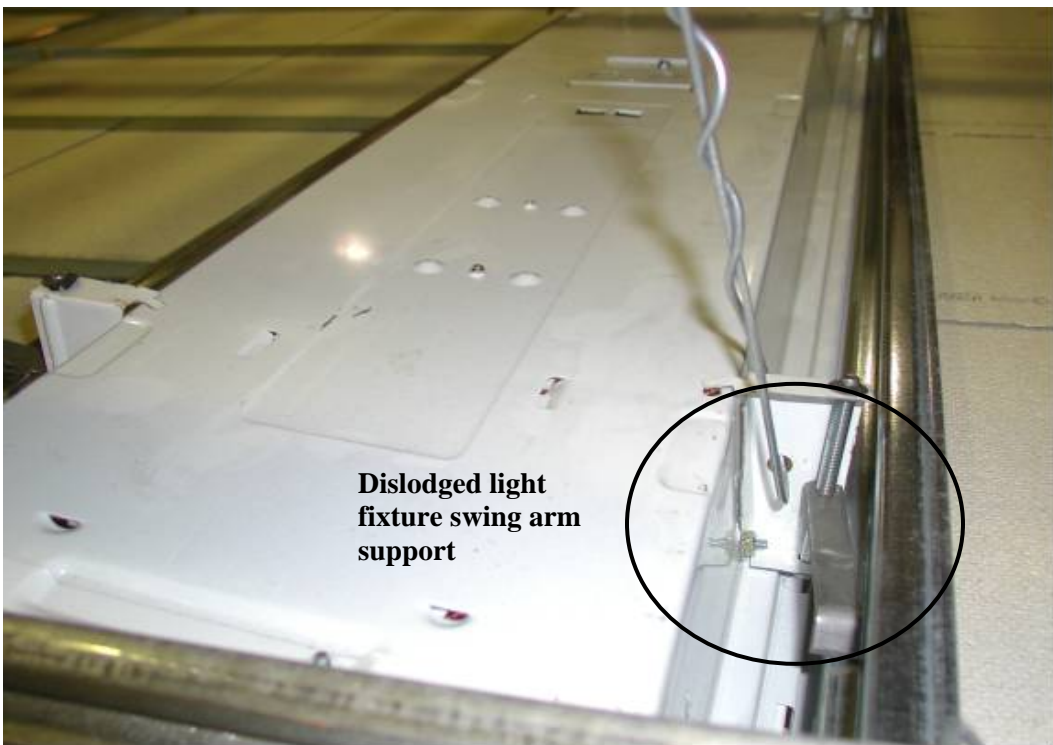
Figure 3–5. Light fixture swing arm support dislodged following Test 21 for ceiling system CS1.

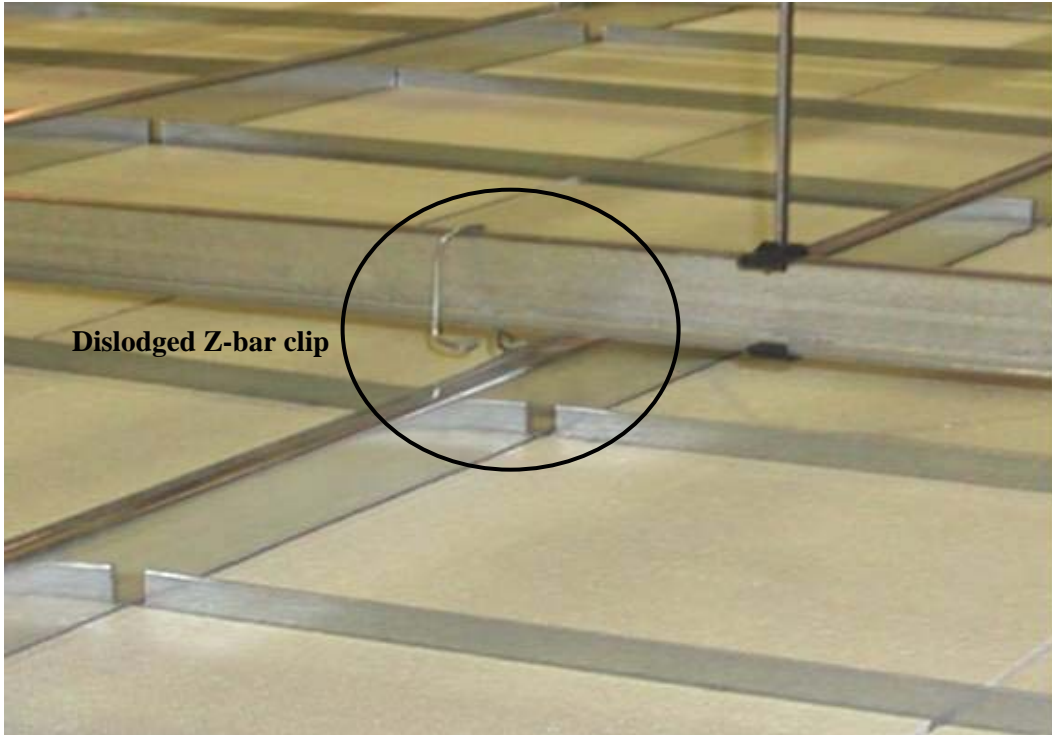
Figure 3–6. Dislodged Z-bar clip in ceiling system CS1 following Test 21.

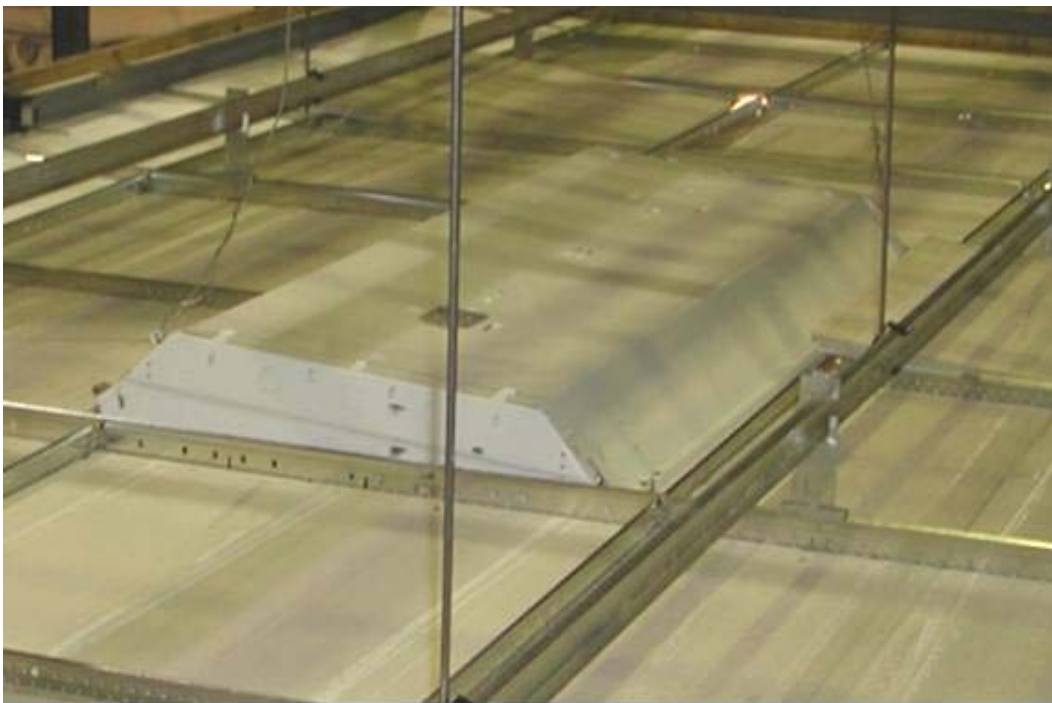
Figure 3–7. Dislodged southern light fixture corner in ceiling system CS2 following Test 14.

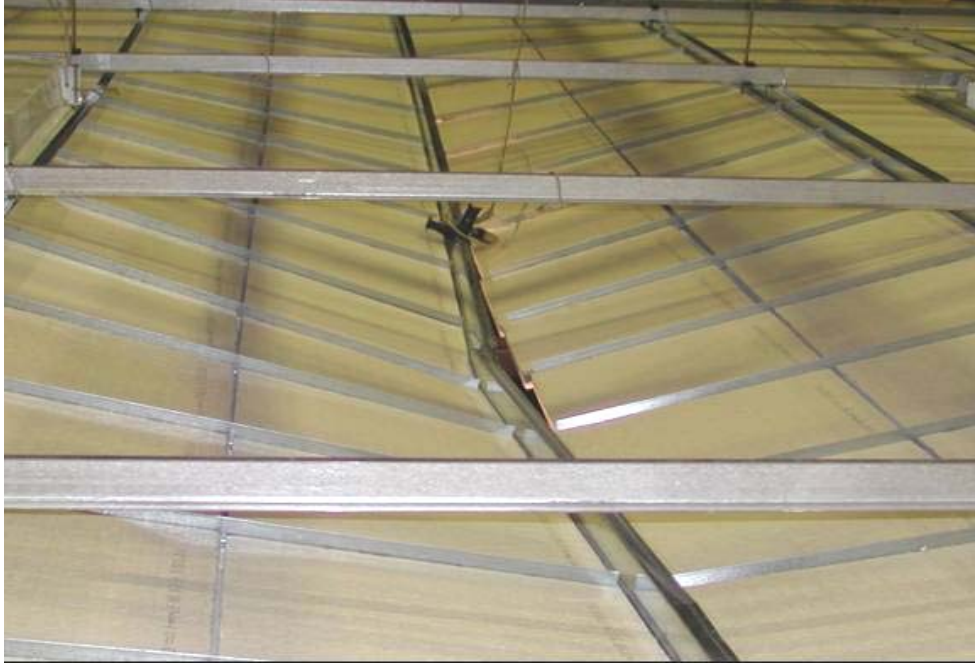
Figure 3–10. Damage to the center of ceiling system CS3 following Test 23.

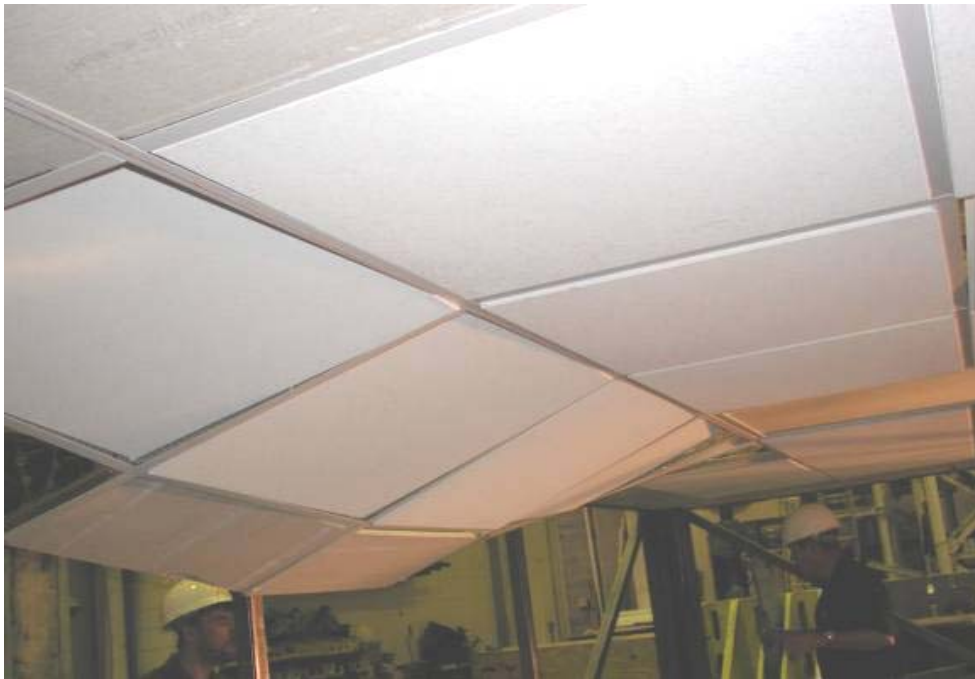
Figure 3–11. Damage to the northern perimeter of ceiling system CS4 following Test 23.

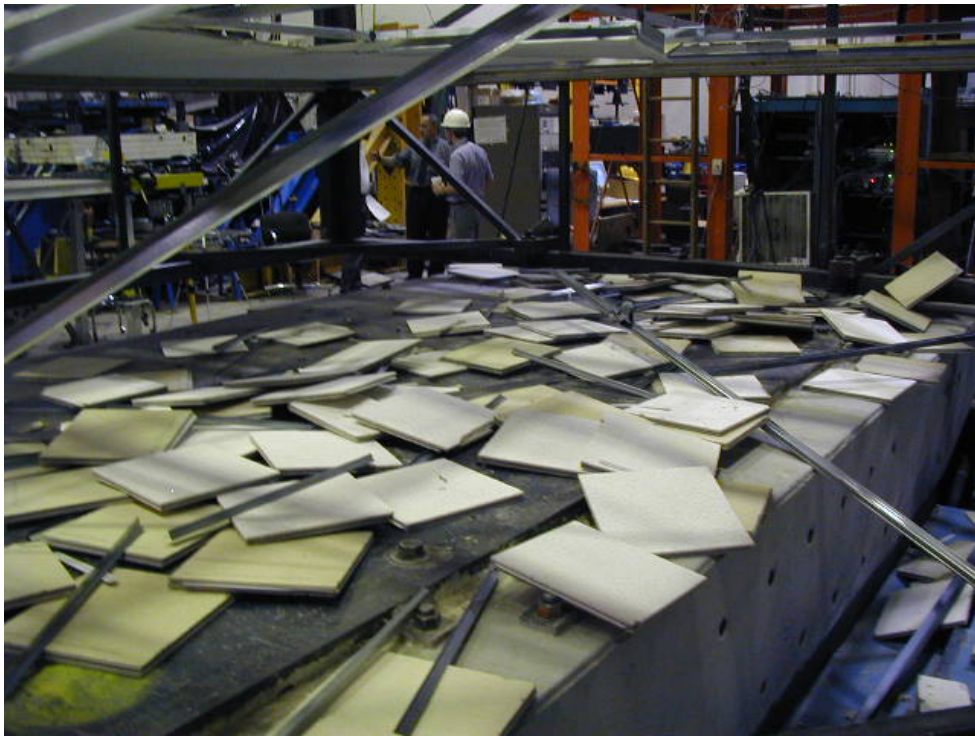
Figure 3–13. Collapse of ceiling system CS3 after 2.5g earthquake excitation.

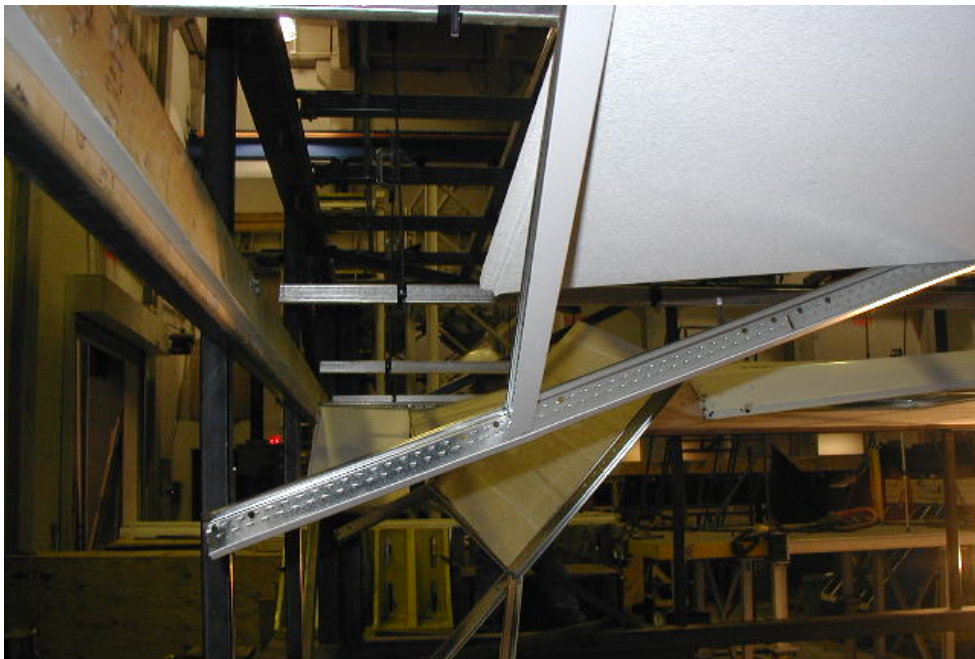
Figure 3–14. Damage to north perimeter of ceiling system CS4 after 1.75g earthquake excitation.

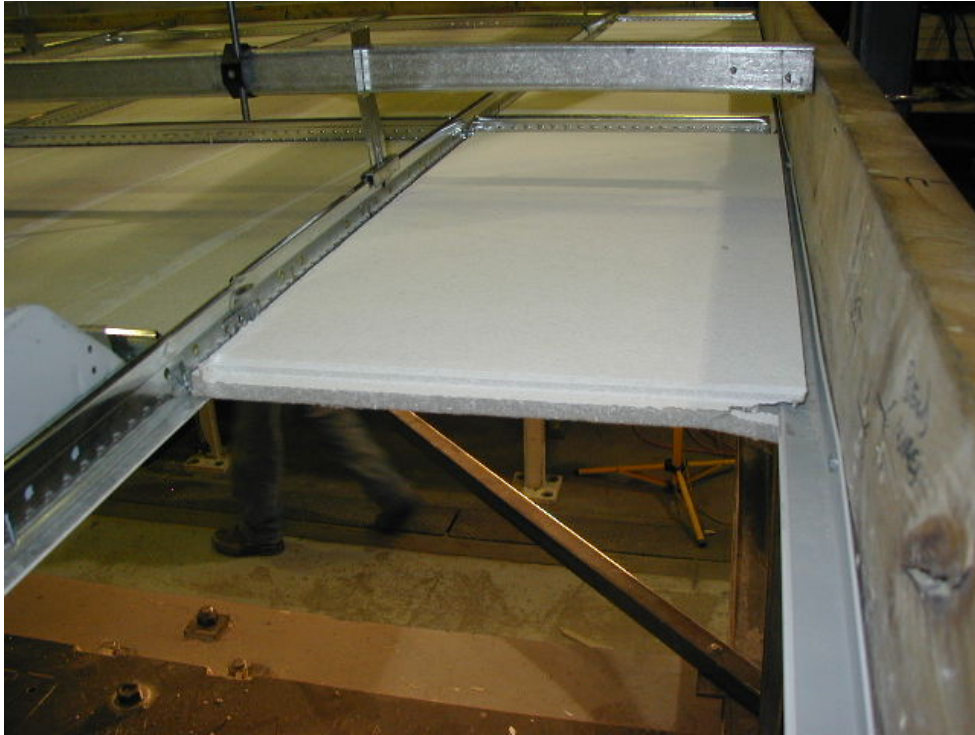
Figure 3–15. Damage to south perimeter of ceiling system CS4 after 1.75g earthquake excitation.
